Rehabilitation of the concrete structure from the soccer stadium Emil Alecsandrescu Iasi - Romania

May – October 2004

CONTRACTOR : SC IASICON SA
SUBCONTRACTOR : SC Rex Pod SRL

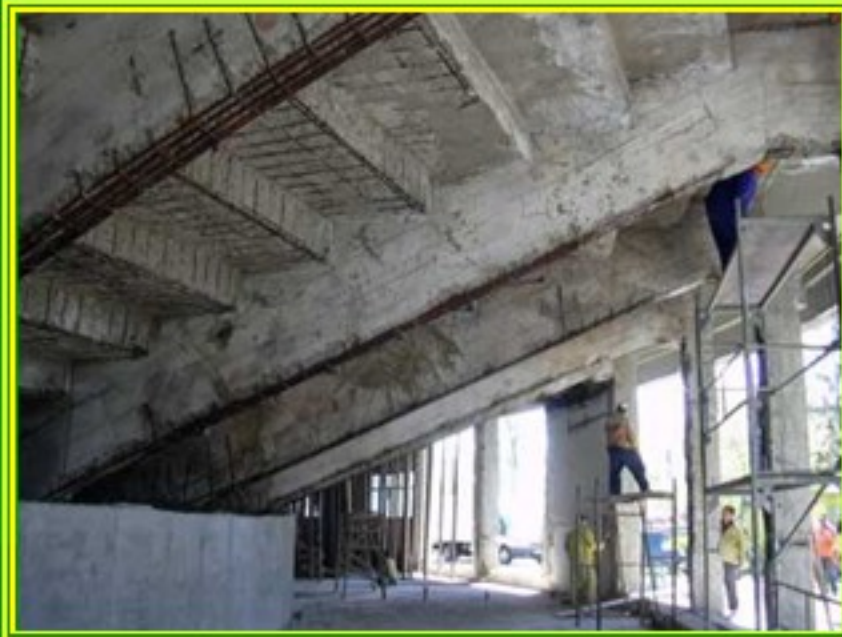
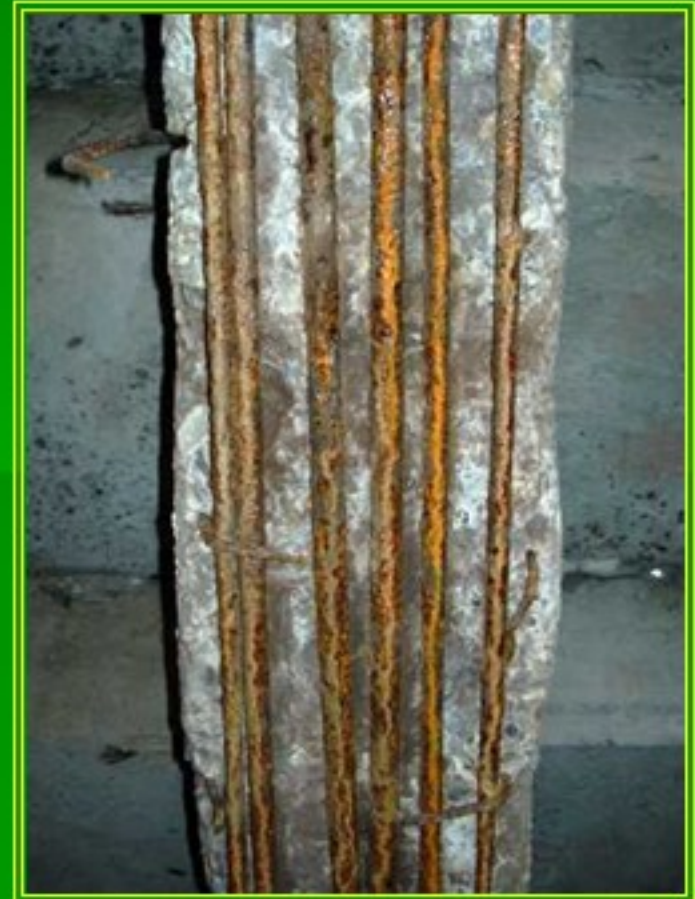
Deteriorations of the concrete structure, segregations, corrosion of the reinforcing steel

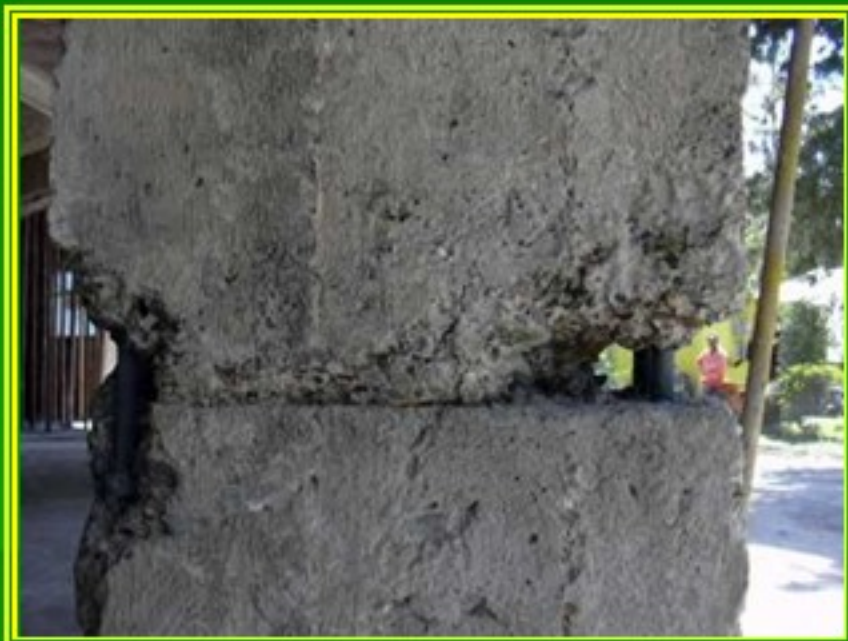
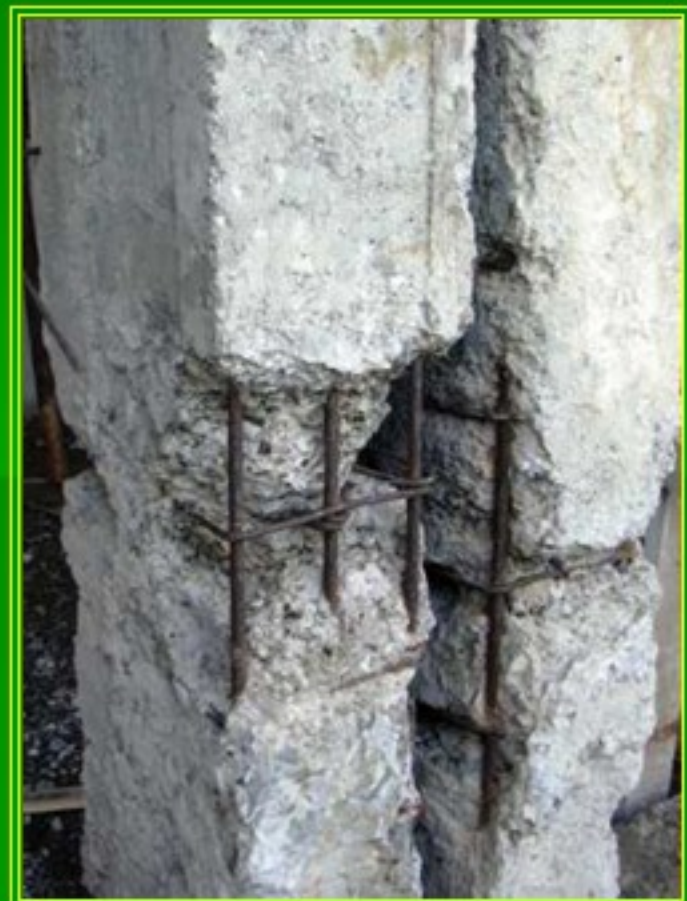
Deteriorations of the concrete structure, segregations, corrosion of the reinforcing steel

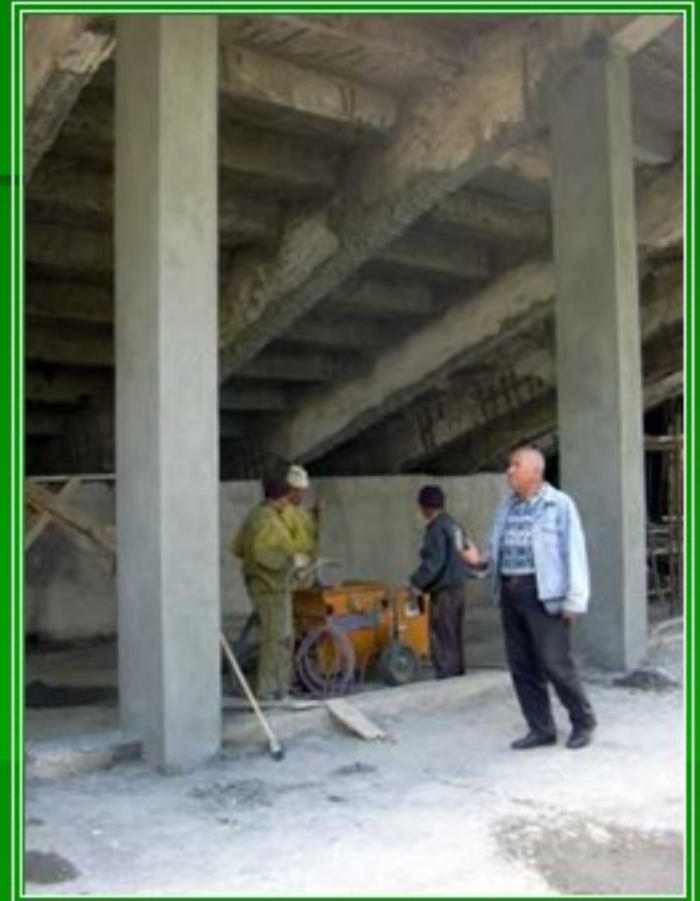
Surface aspect after shootcrete
